The restoration of the cathedral at Kirkjubøur in the Faroe Islands

Poul Klenz Larsen¹, Thorborg von Konow² and Sölve Johansson³

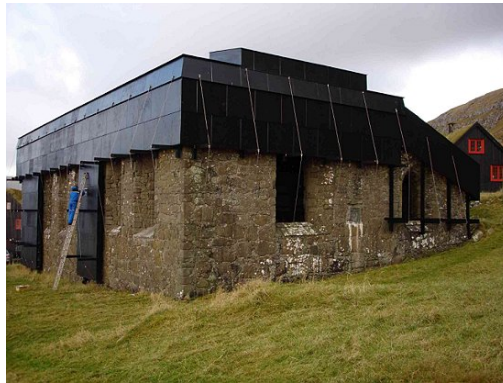
Fig. 1 The ruin of the cathedral in Kirkjuböuf is located at the foot of the hill facing south to the Atlantic Ocean. The temporary shelter protects against the very humid and saline environment.

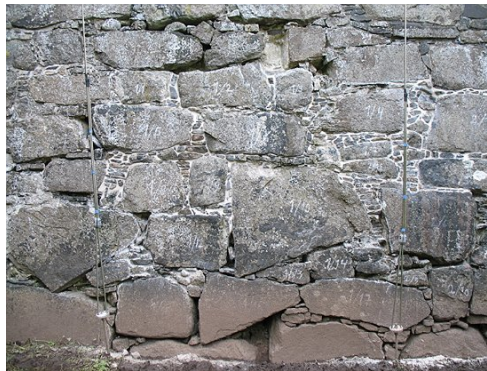
Fig. 2 The walls of the cathedral is made of irregular basalt boulders. The cavities in between are filled with smaller pieces of rock held in place by the mortar. Test area for restoration on the north side of the north wall

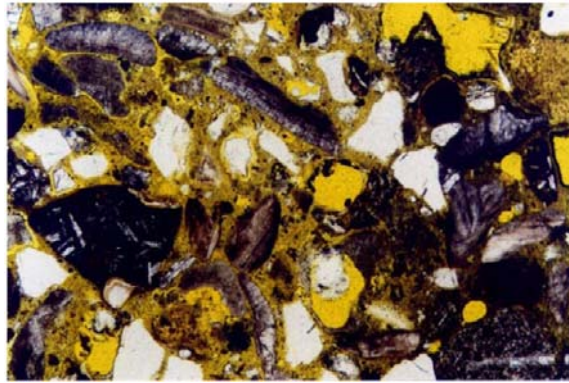
Fig. 3 Thin section of the original mortar in sample 12. The black grains are basalt, the white grains are quartz, the light brown matrix is lime and the grey particles are shell fragments. Yellow areas are pores. The total area is approximately 7 mm². Photo by Thorborg von Konow.

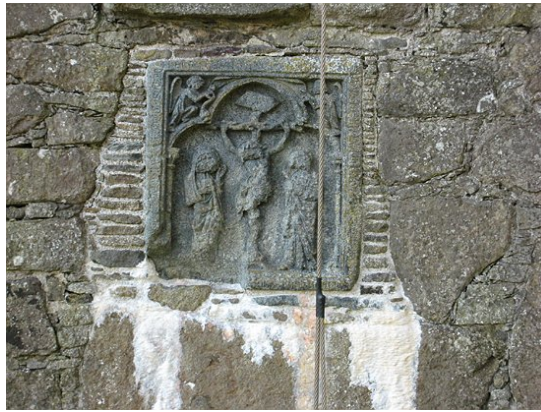
Fig. 5 The lime deposit below the relief on the east wall has leaked from the lime mortar used for the joints.
